BELZONA PROTECTS COAL DIRECTOR

Application: SHM-Solids Handling Machinery

Customer Location: Coal-fired Power Plant - Ontario, Canada

Coal director for pulverizer

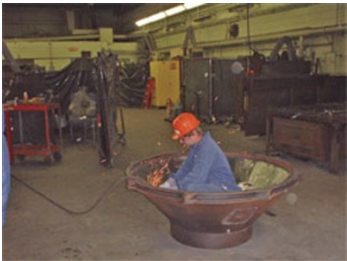
- * Surface preparation ,
- * Product was kept warm with the help of this steam pipe ,
- * Completed application ,

New steel was put in place. Steel was hand prepared and Belzona® 1812 material was put down with 1/8" thickness. This Belzona system provides excellent abrasion resistance, while ensuring the coal moves as required.
