BELZONA REPAIRS AND PROTECTS QUENCH TOWER

ID: 4618

Quench tower suffering Corrosion Under Insulation (CUI).

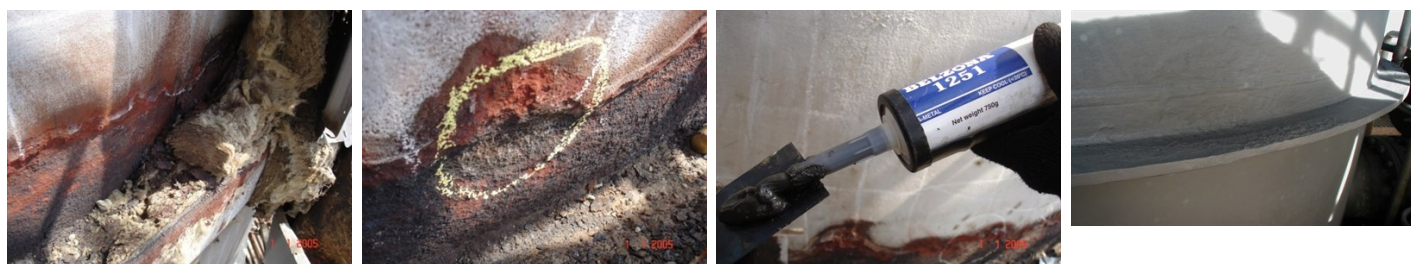
Photograph Descriptions

The tall carbon steel tower contains many trays and is insulated to prevent heat loss. Water penetration and condensation had led to severe CUI in many localised areas. The thickness of tower walls had reduced by more than 50% in some areas.

- * Surface condition behind insulation at 7m height ,
- * Severe damage due to CUI ,
- * Application of Belzona® 1251 ,
- * Completed rebuild with high temperature barrier coating Belzona® 5851 applied to prevent further corrosion ,

Application was carried out in accordance with a modified Belzona Know-How System Leaflet TCC-5. Due to the hazardous area and live tower, scope of surface preparation was limited. Spark free tools were used to remove all loose corrosion back to a sand substrate. Belzona® 1251 was used to repair pitted areas, using doubler plates bonded over the most severely corroded areas. The tower was coated to prevent further corrosion using Belzona® 5851.
