CUSTOM MADE TETHERING STRAPS CREATED WITH BELZONA

ID: 4668

Application: SOS-Ships and Offshore Structures

Customer Location: Oil and Gas Co. Aberdeen, UK

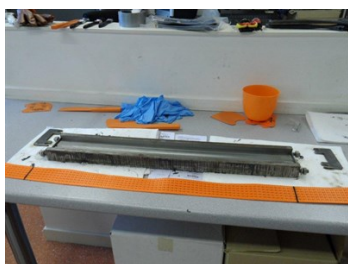
- * Fabricated mould and Cargo Strap ,
- * Belzona® 2221 formed around the strap ,
- * Completed application ,
- * Strap in service ,

Application was carried out in accordance with a modified version of Belzona System Leaflet SOS-13. Using a specially fabricated mould Belzona 2221 was formed around a cargo strap. The mould accurately formed a location ridge in the Elastomer to match groove in the hose flange.
