BELZONA ENSURES LONG-TERM PROTECTION OF TUGBOAT HULL

ID: 4673

Hull plates of a 103' tugboat operated by the refinery

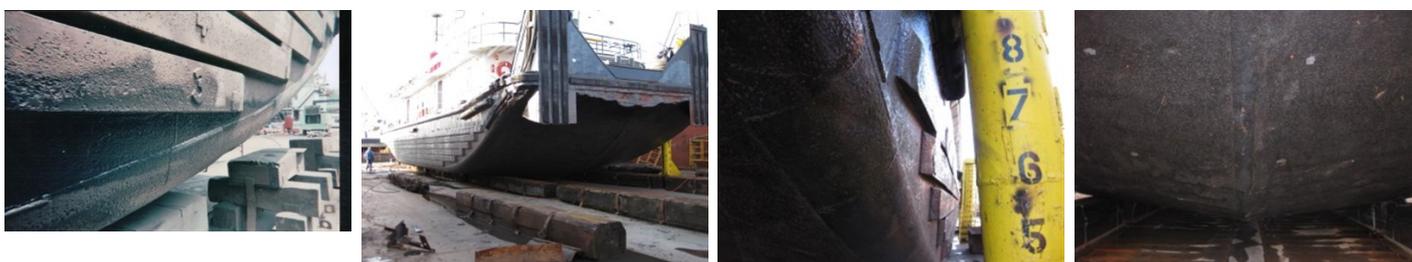
- * Image of hull plates pressure washed and in the process of abrasive blasting ,
- * Hull plates coated with Belzona 5811 ,
- * After 4 years in service, the coating is glossy and tightly adherent ,
- * After 7 years in service, the coating is virtually unchanged ,

The application was carried out in accordance with Belzona Know-How System Leaflet SOS-2. Belzona 5811 was applied via a single-component airless spray.

Belzona has successfully proven to be a high cost-effective solution that has saved the Refinery \$168,000 and provided longer longevity than the conventional solvent coating. A 4-year inspection found the majority of the original coating in a perfect condition, still glossy and tightly adherent. During a 7-year inspection, the coating is virtually unchanged from the 4-year inspection

with both black and beige coats still present at full thickness. After a 9-year inspection, the application is still perfect and operating.
