BELZONA SEALS LEAKING BALCONY ROOF AT WORLD FAMOUS COLLEGE

ID: 4689

Customer Location: College, Cambridge, UK
Application Date: August 2013

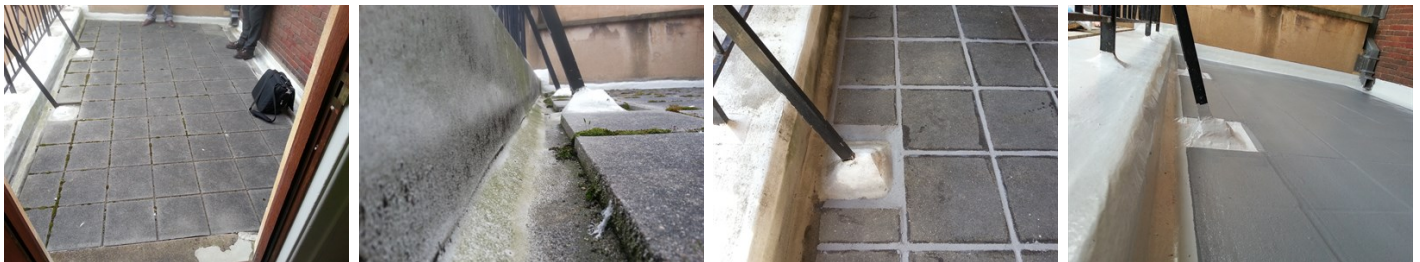
Photograph Descriptions

The asphalt roof was leaking underneath the concrete slabs, causing water damage to the rooms below. To repair the roof the College was planning to remove the concrete slabs, replace the asphalt roof and then reinstall the concrete slabs.

- * Leaking balcony roof with paving slabs ,
- * Close up of paving slab edge ,
- * Gaps between slabs filled with Belzona® 4131 ,
- * Balcony roof coated with Belzona® 3131 system with 3rd coat incorporating Belzona® 9231 aggregate anti-slip system ,

Application was carried out in accordance with Belzona Know-How System Leaflet RPA-6. The gaps between all paving slabs were cleaned and filled with Belzona 4131. A fully reinforced Belzona® 3131 system was then applied to weatherproof the area. This was followed by a further coat of Belzona® 3131 blinded with Belzona 9231 aggregate to create a non-slip walkway.
