BELZONA SEALS LIVE LEAK IN LARGE WATER TANK

ID: 4690

Application: TCC-Tanks and Chemical Containment Areas

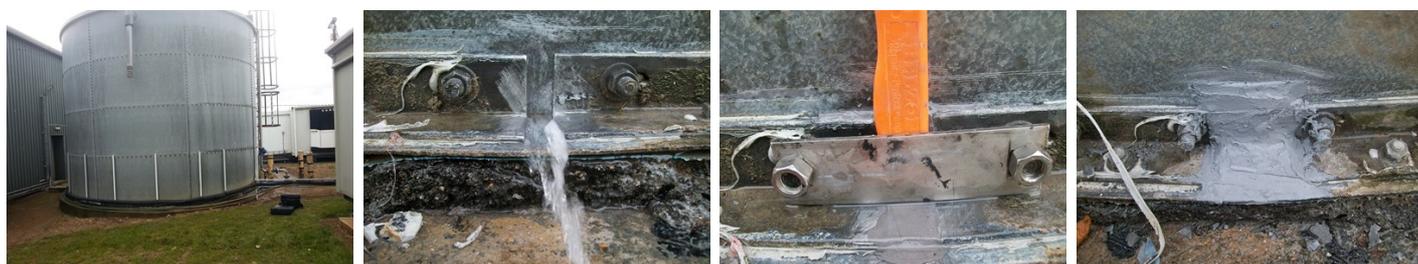
Photograph Descriptions

The tank was leaking at the base due to a failed seal, causing local flooding. The customer had tried to seal the leaking area with other products but this had failed and was still leaking. So a local service company recommended they contact Belzona.

* 1. Large water tank with leaking area at base 2. Leaking area showing water squirting out 3. Leak stopped with Belzona 1291 using clamp to hold it in place against force of leaking water 4. Completed repair coated over with Belzona 1161 & 9341. ,

Application was carried out according to Belzona Know How System Leaflet TCC-1. After removing the previous repair materials and roughening the surface, belzona 1291 used in conjunction with a clamp was used to stem the leak before applying Belzona 1161 incorporating Belzona 9341 (reinforcement Tape) over the area to create a permanent seal.

To drain the large tank to repair the leaking seal area by normal methods and then refill it would close down the factory for 1-2 days costing thousands of pounds in lost production was not an option. Instead they purchased a Belzona Leak Repair Kit, less than £100 of Belzona was used and the live leak was solved in less than 2 hours without stopping any production. This repair was inspected 5 months later and is still in perfect condition with no leaks.
