BELZONA PROVIDES HYGEINE SOLUTION FOR SWEET FACTORY

ID: 4696

Customer Location: Sweet manufacturer, Leeds, UK
Application Date: June 2013

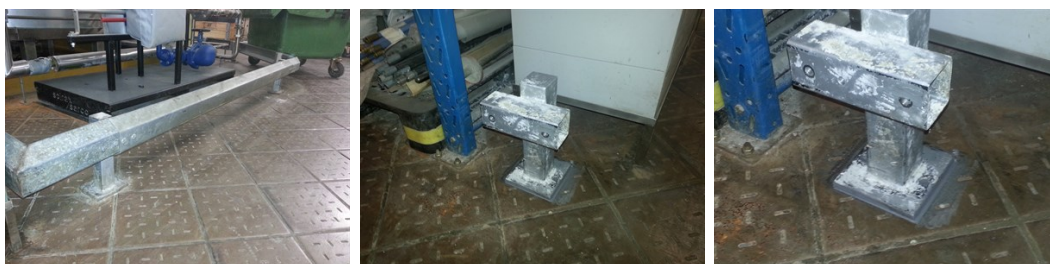
Photograph Descriptions

* 1. Typical crash barrier assembly 2 . Crash barrier base bonded to steel tile 3. Close up after cure ,

Application was carried out using a midified version of Belzona System Leaflet FPA-11. Both the steel tiles on the floor and steel base of the crash barriers were prepared using an MBX Bristle Blaster before being bonded together using Belzona 1111. Care was taken to ensure Belzona 1111 exuded from all edges and was used to create a smooth fillet around the base.
