BELZONA PROTECTS TANK ROOF WITH MINIMAL EFFORT

ID: 4723

Industry: Chemical & Petrochemical
Application: TCC-Tanks and Chemical Containment Areas

Customer Location: Petrochemical Plant, UK.
Application Date: 2013

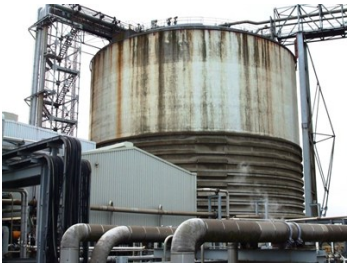
Roof of chemical tank was suffering severe corrosion but due to the highly explosive nature of the tanks contents, no hot works or mechanical tools could be used. The customer wanted an anti corrosion system that would bond with minimal preparation and be flexible enough to move with the tank. As the whole roof is subject to regular inspections, they also wanted a system that could offer good traction under foot on this domed surface.

- * Chemical tank of 29m height ,
- * Corroded domed roof ,
- * Application of Belzona® 5831 with Belzona® 9211 in the top coat ,
- * Phase 1 completed ,

Application was carried out in accordance with Belzona Know-How System Leaflet TCC-5. Preparation was limited to hand wire brushing. 2 coats of Belzona 5831 were applied with Belzona® 9211 broadcast into the surface to create a positive grip..
