BELZONA PROTECTS TANK ROOF WITH MINIMAL EFFORT

ID: 4723

Customer Location: Petrochemical Plant, UK.
Application Date: 2013

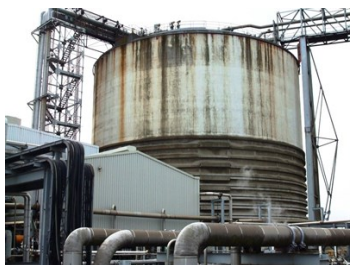
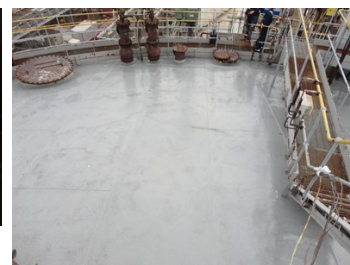
Roof of chemical tank was suffering severe corrosion but due to the highly explosive nature of the tanks contents, no hot works or mechanical tools could be used. The customer wanted an anti corrosion system that would bond with minimal preparation and be flexible enough to move with the tank. As the whole roof is subject to regular inspections, they also wanted a system that could offer good traction under foot on this domed surface.

- * Chemical tank of 29m height ,
- * Corroded domed roof ,
- * Application of Belzona® 5831 with Belzona® 9211 in the top coat ,
- * Phase 1 completed ,

Application was carried out in accordance with Belzona Know-How System Leaflet TCC-5. Preparation was limited to hand wire brushing. 2 coats of Belzona 5831 were applied with Belzona® 9211 broadcast into the surface to create a positive grip..

Phase 1 of this project on the main roof dome covered 540m2 and included many pipes and gantry legs. All were prepared with

hand tools to eliminate the possibility of sparking. Belzona 5831 offered a solvent free solution with excellent adhesion. With the Belzona 9211 incorporated, it afforded assured grip, even in wet conditions. The client was delighted with the results and is due to repeat the application on other parts of the site.
