# NOVEL USE OF BELZONA TO SEAL TURBINE HALL ROOF

ID: 4725

Customer Location: CCGT Power Station, Runcorn, UK  
Application Date: March 2012

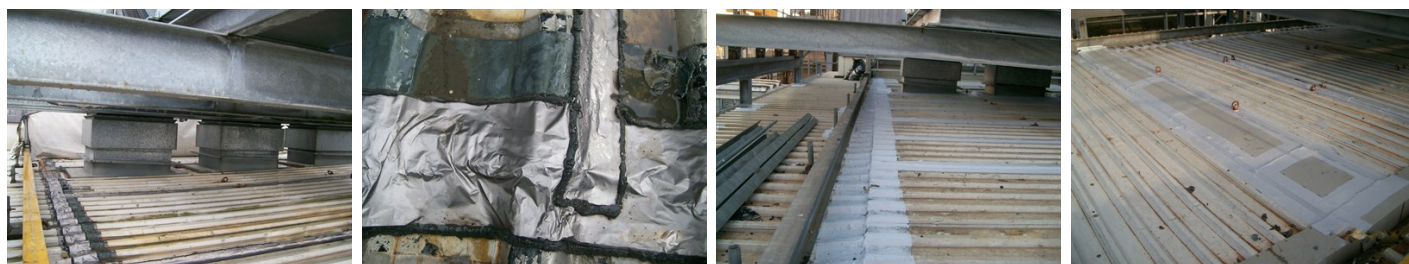
*Each time one of the turbines is removed through the roof, Bitumen Flash Band has to be scraped off (very time-consuming) and replaced. The Flash Band does not lend itself to this type of treatment and was letting rainwater into the Turbine Hall. The customer wanted a more convenient way of removing and re-sealing the roof panels.*

- \* General view of turbine hall roof showing Bitumen Flash Band on joints before stripping ,
- \* Close-up of Bitumen Flash Band on joints ,
- \* General view of roof after stripping the joints and sealing with Belzona 3131 ,
- \* Another view of the finished roof joints ,

To allow turbine removal a knife is run down the joints. The joints are easily resealed with a further coat of Belzona 3131 and Reinforcing sheet. Belzona 3131 is easy to apply and lightweight, so procedure can be carried out time and again without detriment to the roof.
