BELZONA SEALS & WEATHERPROOFS ASBESTOS SCHOOL ROOF

ID: 4731

Customer Location: School, Galashiels, Scotland
Application Date: July 2013

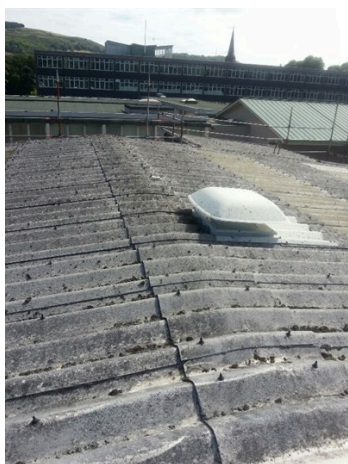
The roof had been leaking for years. Patch repairs had been tried but the water always found another way in. Client requested a complete and long term solution.

* 1. Before power wash 2. After surface preparation 3. Applying the Belzona 3111 Membrane system 4. Finished section of roof ,
