BELZONA SEALS CANOPY ROOF

ID: 4739

Customer Location: Bus Station, Lancashire, UK
Application Date: Sept 2012

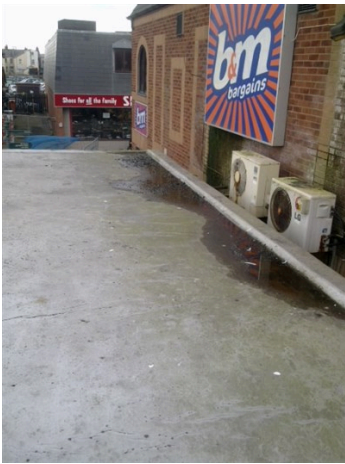
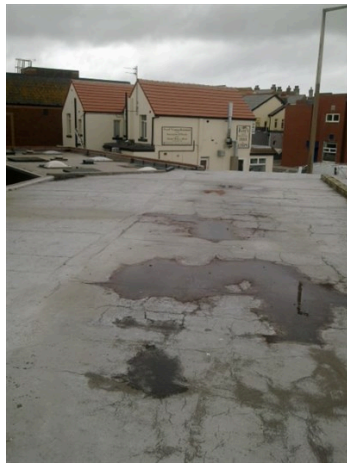
Asphalt roof covered with solar reflective paint had deteriorated due to coastal winds, sea spray and uv light over a number of years. The roof was now leaking. Customer needed roof to be fully waterproof especially as this was to be part of a new bus station.

- * 1 & 2 General views of the roof before work commenced ,
- * 3 & 4 Completed roof showing seamless finish achieved ,

Application was carried out in accordance with Belzona System Leaflet RPA-6. A simple pull-off test was done to determine which conditioner was best for the weathered solar reflective paint. This proved to be Belzona 3911 (PSC Conditioner). Roof was power washed and Belzona 3911 applied. Two coats of Belzona 3111 were applied with Reinforcing sheet. The result was fully sealed waterproof roof with a seamless finish.
