# BELZONA PROTECTS PIPEWORK ON SEWAGE OVERFLOW SYSTEM

ID: 4740

Industry: Water / Wastewater  
Application: VPF-Valves, Pipes and Fittings  
Substrate: Mild steel  
Products: \* Belzona 5811 (Immersion Grade) ,

Customer Location: Water company, Essex, UK  
Application Date: August 2012

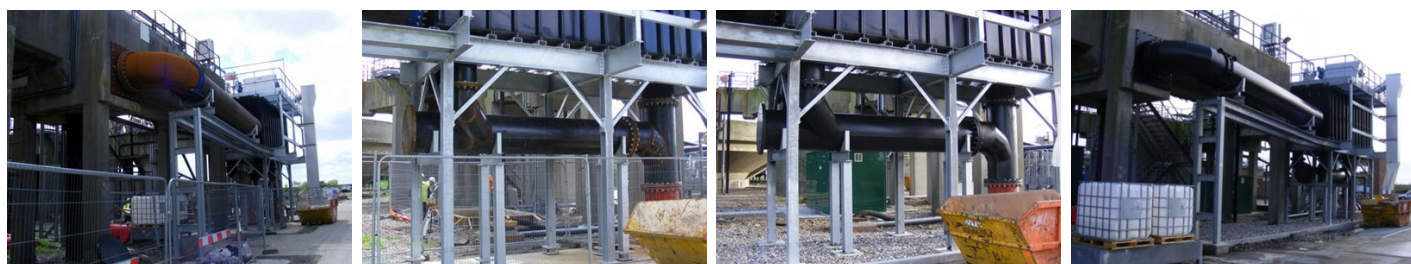
## Photograph Descriptions

The newly fitted pipework had a paint system which was already showing signs of failure. Client required system to provide long term corrosion protection and be resistant to raw sewage.

\* 1. Upper pipework 2. Lower pipework 3. & 4. Completed pipework ,

Application was carried out in accordance with Belzona Know-How System Leaflet VPF-2 and the Belzona 5811 Instructions-for Use leaflet.

The customer was looking for a system that would provide chemical resistance as well as being a long lasting coating. Being only a two coat application allowed a quick turn-around. Local by-laws required that all newly erected structures on-site to be coated black.
