BELZONA COATS SUPER YACHT

ID: 4805

Industry: Marine
Application: SOS-Ships and Offshore Structures

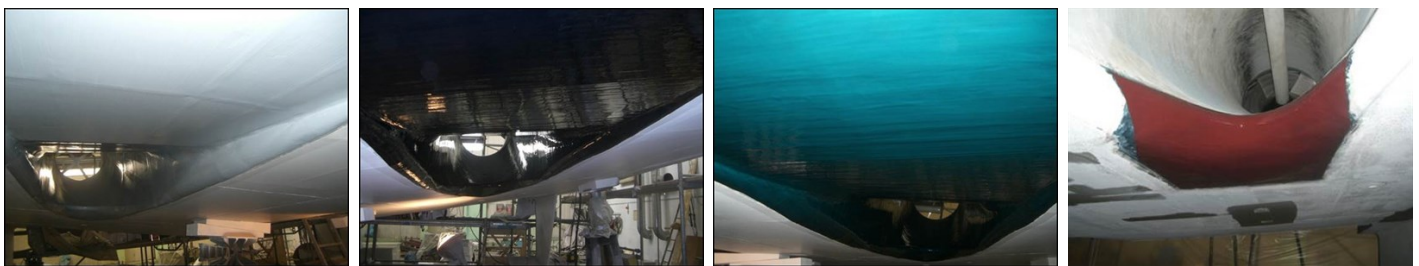
Constructed with three Rolls-Royce gas turbine engines capable of pushing her to record speeds of 80knots, the jet tube area was suffering from high amounts of erosion and cavitation so when the vessel docked in Germany, Belzona provided a solution.

- * Jet tubes coated with Belzona 1341 ,
- * 1st coat of Belzona 2141 ,
- * 2nd coat of Belzona 2141 applied ,
- * After three years in service local repair was carried out on leading edge ,

Application was carried out in accordance with Belzona Know-How System Leaflets SOS-1 & SOS-2. Rebuilding of the damaged area was carried out using Belzona 1111, before being coated with the Belzona 2141 system to provide cavitation resistance. Belzona 1341 was used as the first coat to provide optimum adhesion and corrosion resistance.

Belzona was inspected after 3 years and was mostly found to be in perfect condition with only minor damage to the leading edge. The coating had overcome the major cavitation erosion problems and was easily repaired with minimal downtime.
