BELZONA SEALS FIELD JOINTS ON PLATFORM RISER

Industry: Oil & Gas
Application: SOS-Ships and Offshore Structures

Customer Location: Major Oil Company, Azerbaijan
Application Date: June, 2008

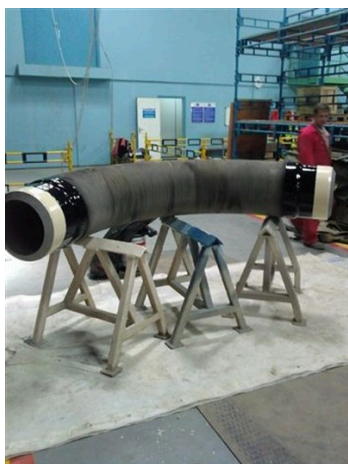
- * Trials carried out in clients workshop ,
- * First coat of Belzona 2141 being applied ,
- * Some of the sealed riser joints ,
- * Close up of a sealed joint ,

by a series of trials carried out in the clients workshops, led to all 42 joints being encapsulated with the Belzona system

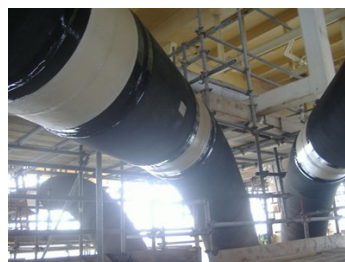
42 field joints on under-deck riser.
