# BELZONA IN WATERWORKS' PUMP SAVES OVER \$7,200 ANNUALLY

ID: 483

Customer Location: Des Moines Water Works, Des Moines,  
Iowa USA

Application: CEP-Centrifugal Pumps

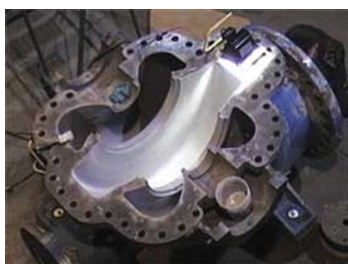
Erosion and bearing problems.

- \* Surface prepared for application ,
- \* The impeller was also repaired/protected with Belzona ,
- \* In progress ,
- \* Complete, and ready for re-assembly ,

Repair of erosion damage with Belzona® 1221 (Super E-Metal). Then a two-coat application of Belzona® 1341 (Supermetalgilde) was applied. Belzona® 1341 is approved by NSF for potable water contact. Performance tests showed an average increase of water efficiency of 7.2%, which will save over \$7,200 annually.
