BELZONA IN WATERWORKS' PUMP SAVES OVER \$7,200 ANNUALLY

Customer Location: *Des Moines Water Works, Des Moines, Iowa USA*

Application: *CEP-Centrifugal Pumps*

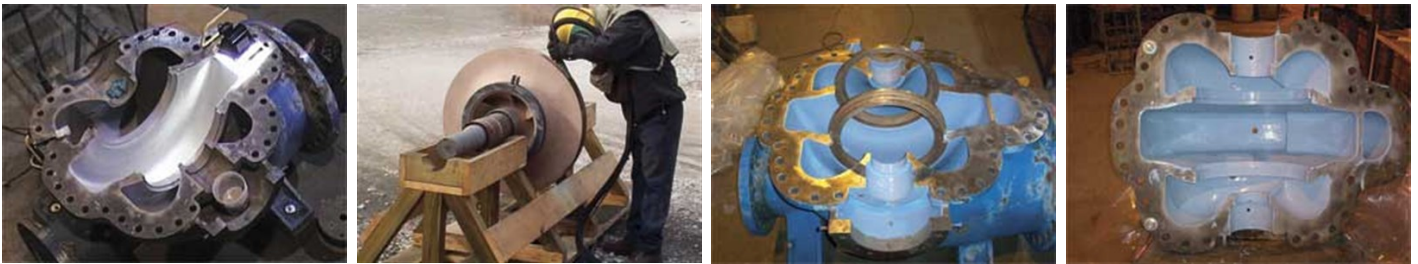
Erosion and bearing problems.

- * Surface prepared for application ,
- * The impeller was also repaired/protected with Belzona ,
- * In progress ,
- * Complete, and ready for re-assembly ,

Repair of erosion damage with Belzona® 1221 (Super E-Metal). Then a two-coat application of Belzona® 1341 (Supermetalglide) was applied. Belzona® 1341 is approved by NSF for potable water contact. Performance tests showed an average increase of wire to water efficiency of 7.2%, which will save over \$7,200 annually.
