# BELZONA ENSURES TIGHT FIT OF DRAGLINE BUCKET TEETH

ID: 4882

Bucket teeth shimming

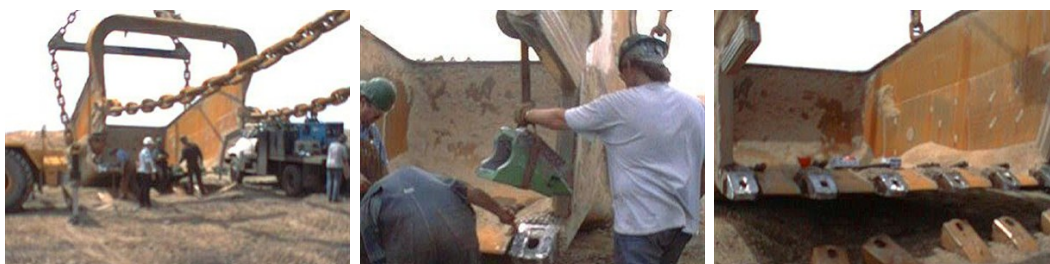
- \* Dragline bucket overview ,
- \* Application of Belzona 1111 ,
- \* Complete application ,

Application was carried out in accordance with Belzona Know-How System Leaflet GSS -9.

Using Belzona 1111 as a shim when replacing the teeth allowed for a tight fit and was easily repaired with minimal downtime.
