SHAFT REPAIR AT WASTE WATER PLANT

ID: 4904

Industry: *Water / Wastewater*
Application: *MPT-Mechanical Power Transmission*

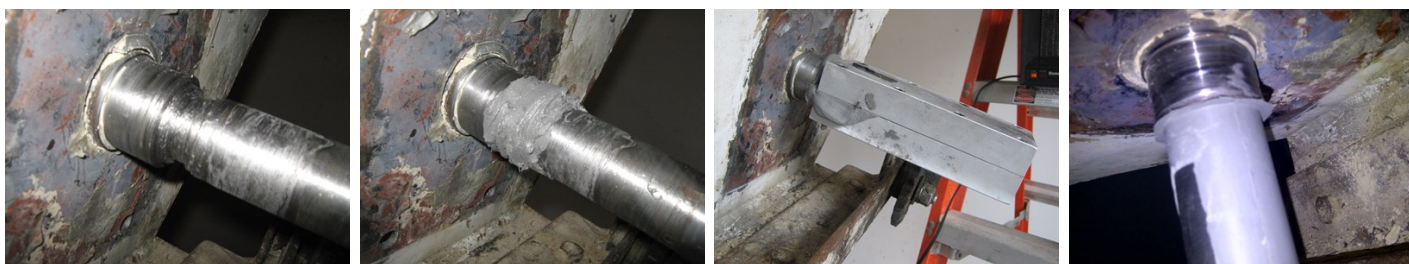
Shaft became worn due to bearing failure

- * Shaft prior to the application ,
- * Application in process ,
- * Application with formers ,
- * Formers removed and application completed ,

Damaged shaft at a waste water plant

Application was carried out in accordance with Belzona Know-How System Leaflet MPT-2. Damaged area was prepared with a grinder to make the surface rough and ready for the application. The surface of the formers were treated with Belzona 9411, applied in 2 coats in accordance with the Belzona Instructions For Use. Belzona 1111 was applied to the shaft and the formers. Then the formers were attach to the shaft allowing the Belzona 1111 to cure in accordance with the Belzona Instructions For Use. A suitable emery cloth/crocus paper was used to complete the application.
