INVISIBLE WATERPROOF COATING FOR EXTERNAL WALLS

ID: 4905

Application: *WPA-Wall Problem Areas*

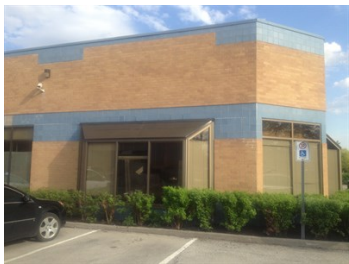
Water was penetrating the brick and mortar, creating damp areas on internal wall.

- * Walls prior to application ,
- * Preparation completed ,
- * Application underway ,
- * Completed application ,
