BELZONA PROTECTS 50,000 SQ.FT FLOOR AREAS OF A TECHNOLOGY CENTER & LABORATORY

ID: 4932

Application: *FPA-Floor Problem Areas*

Customer Location: *Copper Mine, Arizona*

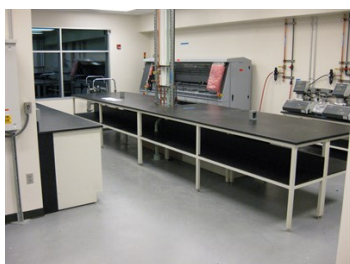
- * Laboratory floor areas protected with Belzona 4311 ,
- * Laboratory floor areas protected with Belzona 4311 ,
- * General floor areas protected with Belzona 5811 ,
- * Laboratory floor areas protected with Belzona 4311 ,

Application was carried out in accordance with Belzona Know-How System Leaflet FPA-3, following the 28 day curing process of the newly poured concrete. Belzona 5811 was applied to general floor areas and Belzona 4311 - to laboratory floors. The application of the coating systems was successfully completed using a combination of squeegee and paint rollers.
