Belzona® 3111 (Flexible Membrane) Protection in a Power Plant

ID: 504

Customer Location: Power Authority, San Antonio, Texas USA

Application Date: 2002

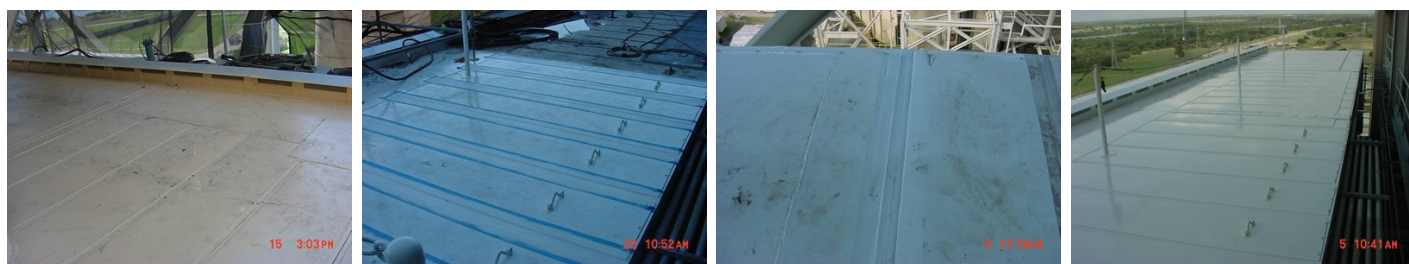
Photograph Descriptions

Water getting through collapsible roof seams wets coal and reduces fuel efficiency. Work area extremely dirty due to coal fines from belts.

- * Roof over cascade area prior to the application (note seams). ,
- * Seam areas taped off. ,
- * First coat of Belzona® 3111 applied. ,
- * Completed roof. (Roof was painted following the application of the Belzona.) ,

Application was carried out in accordance with a modified version of Belzona® Know-How System Leaflet RPA-1.

Belzona® 3111 is ideal for waterproofing roofs where movement is present. Seams were designed into this roof as a safety precaution and the reinforced Belzona system ensures areas below stay dry.
