# BELZONA COLD PLATE BONDING ON BULK FUEL HOLDING TANK

Customer Location: Fuel Distribution Terminal, South Wales  
UK

Application: TCC-Tanks and Chemical Containment  
Areas

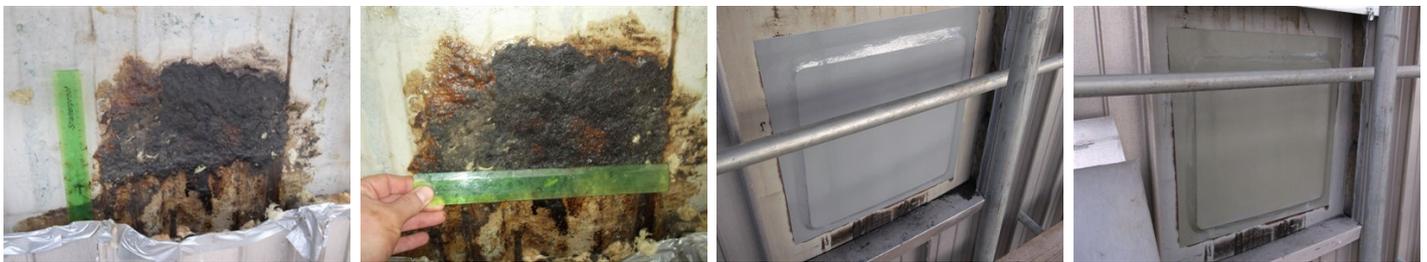
- \* 1 & 2. Original side wall tank hole/leak area ,
- \* 3. Completed application February 2013 ,
- \* 4. Application checked April 2014 ,

Insulated bulk holding tank containing heavy fuel oil. Corrosion under insulation had led to a through wall penetration at approximately 8m above ground level.

Due to the urgency, Belzona were quickly mobilised and prepared the substrates by grit blasting to the desired standard, bonding a 500x500x5mm plate using Belzona 1161 and final two coat system Belzona 5811 in accordance with Belzona System leaflet TCC-3.

In accepting the Belzona cost effective, safe cold bonding solution, the client duly received the fuel shipment and recharged the bulk holding tank without any fault from the application. This saved the client many thousands of pounds in delaying a sea shipment at port side. The application continues to be regularly monitored without any indication of deterioration or need to be
