LIFTING DEVICE FOR FENDER

ID: 508

Industry: Marine
Application: SOS-Ships and Offshore Structures

Customer Location: Keppel Shipyard, Philippines
Application Date: March 2005

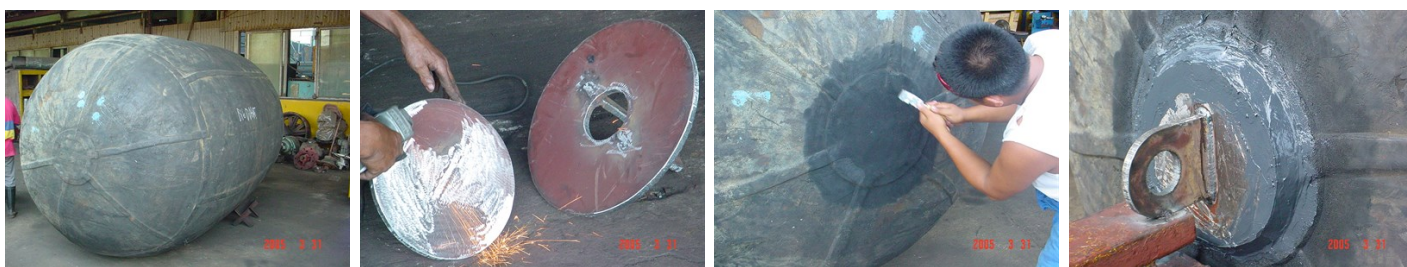
Photograph Descriptions

Transporting an 800kg fender from one area to another possess serious problem without a lifting device. Ships paints get damaged by temporary lifting cables during rough sea conditions.

- * Fender without lifting device ,
- * A 12" diameter plate is prepared with lifting hook ,
- * Surface preparation for the fender ,
- * Finished application & metal lifting device is attached to the fender ,

Attaching metal lifting device to 800kgs rubber fender

The application was performed in accordance with Belzona Know-How System Leaflet SOS-12.

Previously, fenders are wrapped with tires tied with metal cables. On rough seas, ships paints get damaged by the metal cables. Putting a metal lifting device using Belzona® Elastomers was the right solution.
