Belzona Seals Cooling Tower at Government Building

ID: 509

Customer Location: Municipal Building - Ontario, Canada
Application Date: April 2005

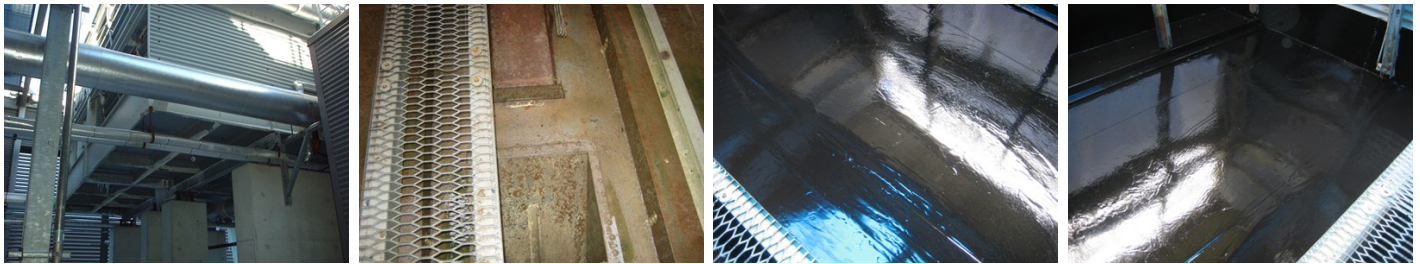
Photograph Descriptions

Corrosion and leaks particularly at joints.

- * Exterior image of cooling tower ,
- * Interior image of the problematic cooling tower ,
- * Belzona 5811 applied ,
- * Another shot of the cooling tower, ready for service ,

Application was carried out in accordance with Belzona Know-How System Leaflet TCC-15.

Belzona® 5811 (Immersion Grade) is ideal for the protection of cooling tower basins. Belzona® 1221 (Super E-Metal) was used to repair areas more severely damaged prior to the coating application.
