# BELZONA PREVENTS SLIPPAGES ON SPEED UP WHEELS

ID: 5214

Speed up wheels.

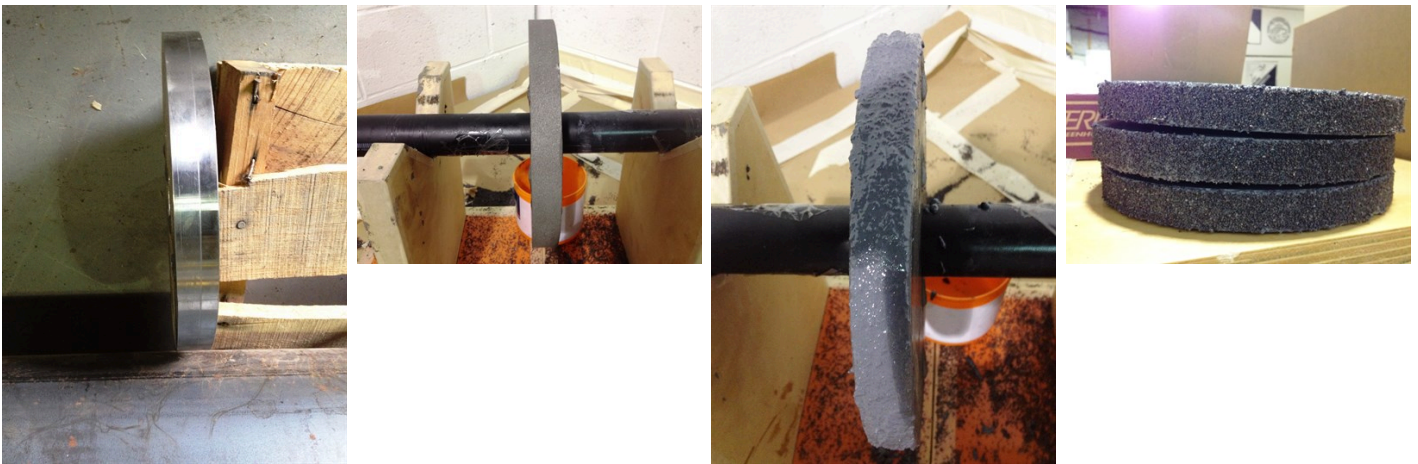
*Original equipment manufacturer of a sawmill and lumber handling equipment require a positive grip to move timber on its machinery.*

- \* Prior to application ,
- \* Surface preparation ,
- \* Application ,
- \* Completed application ,

The application was carried out in accordance with Belzona Know-How System Leaflet SHM-12 for applying grip systems to prevent slippages. Once the surface was blasted to prepare the area, Belzona 1321 was brush applied and Belzona 9211 was broadcasted onto Belzona 1321.
