BELZONA PREVENTS SLIPPAGES ON SPEED UP WHEELS

ID: 5214

Industry: General Industry
Application: SHM-Solids Handling Machinery

Customer Location: Lindsay, ON, Canada
Application Date: August 2013

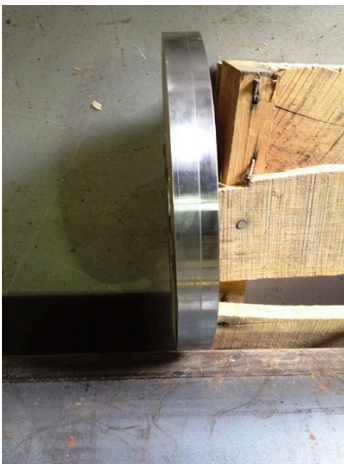
- * Prior to application ,
- * Surface preparation ,
- * Application ,
- * Completed application ,

The application was carried out in accordance with Belzona Know-How System Leaflet SHM-12 for applying grip systems to prevent slippages. Once the surface was blasted to prepare the area, Belzona 1321 was brush applied and Belzona 9211 was broadcasted onto Belzona 1321.
