LOADING DOCK DRAIN COATED WITH BELZONA

ID: 5242

Industry: Buildings & Structures
Application: FPA-Floor Problem Areas
Substrate: Concrete
Products: * Belzona 5811 (Immersion Grade),

Customer Location: Mississauga, ON, Canada
Application Date: September 2013

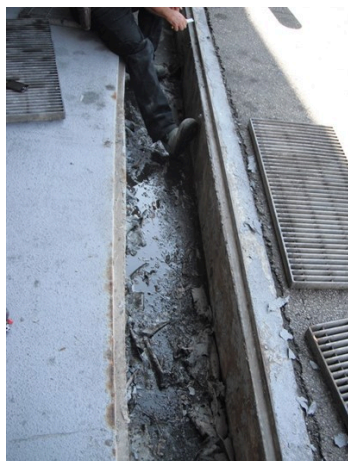
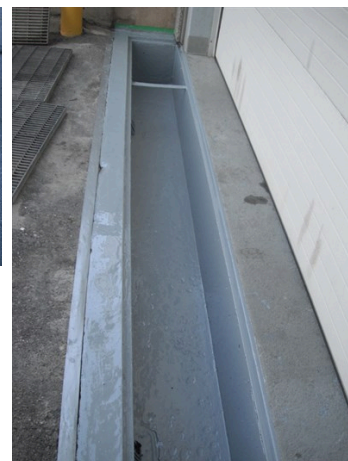
The existing coating had failed, causing blockage of the drain.

- * Prior to application ,
- * Preparation in progress ,
- * Application in progress ,
- * Completed application ,

The application was carried out in accordance with Belzona Know-How System Leaflet FPA-3 for protecting floors and drains against chemical attack. The surface was prepared for application by removing the existing coating and cleaned with a high pressure washer. Belzona 5811 was applied as a two coat system with a short bristle brush.
