BELZONA OFFERS SLIP RESISTANT COATING ON STAIRCASE

ID: 5243

Application: FPA-Floor Problem Areas

Staircase access to car park.

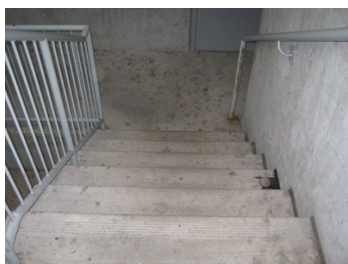
The customer wanted a coating that was slip resistant and offered protection from salt contamination.

- * Prior to application ,
- * Completed application ,
- * Completed application ,

The application was carried out in accordance with Belzona Know-How System Leaflet FPA-3 for protecting floors and drains against chemical attack. The surface was prepared by power washing the surface to remove dirt, debris and salt contamination. A diamond grinder was used to abrade the surface and remove small floor imperfections. Belzona 5231 was applied for the first coat and Belzona 9221 was broadcasted for increased antiskid properties. A second coat of Belzona 5231 was applied within the overcoat window in accordance with Belzona Instructions For Use.
