# BELZONA MOUNTS CELL PHONE ANTENNAS

ID: 5249

Attaching steel plates to the top of a water tower for the purpose of mounting expensive new cell phone antennas.

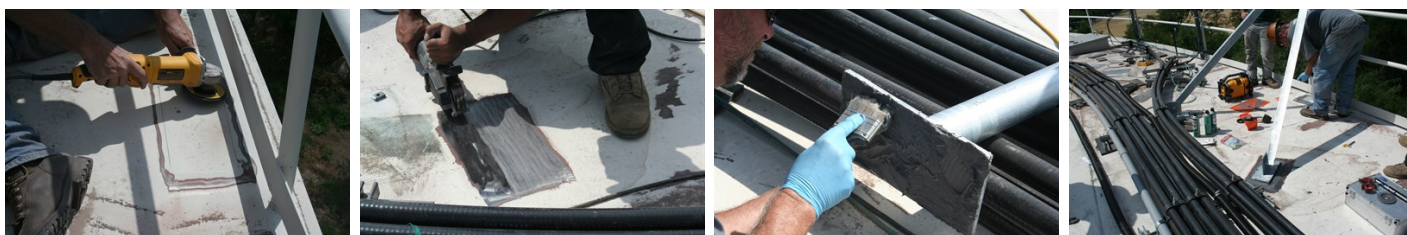
## Photograph Descriptions

- \* Preparing the area 1" wider than the plate all the way around for proper application. ,
- \* Final surface preparation using the MBX Bristle Blaster. ,
- \* Scrubbing it in with a brush. ,
- \* Putting it in place. Job completed. ,

The IFU for the Belzona 1111 was followed. The MBX Bristle Blaster was used to prepare the tank. A grinder with a coarse wheel was used to prepare the plates. Non-chlorinated cleaner was used to clean the surfaces prior to the application.
