# BELZONA BONDS PLATES AT 150' IN THE AIR

ID: 5251

Customer Location: Airway Heights, WA, USA  
Application Date: June 2014

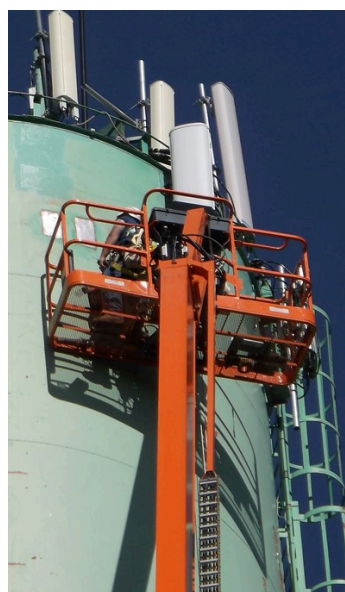
- \* 1. Plates prepared ,
- \* 2. Close-up of the prepared plates ,
- \* 3. Ready to mount the plates ,
- \* 4. Overview of cell phone antenna ,

Surface preparation on the plates was done with a grinder and the tank was done with MBX Bristle Blaster. After application, the

plates were held in place using 80lb. magnets placed underneath, and 'Gorilla' tape across the top until the Belzona 1111 had cured.
