BELZONA BONDS PLATES AT 150' IN THE AIR

Industry: *General Industry*
Application: *TCC-Tanks and Chemical Containment Areas*
Substrate: *Steel*
Products: ** Belzona 1111 (Super Metal) ,*

Customer Location: *Airway Heights, WA, USA*
Application Date: *June 2014*

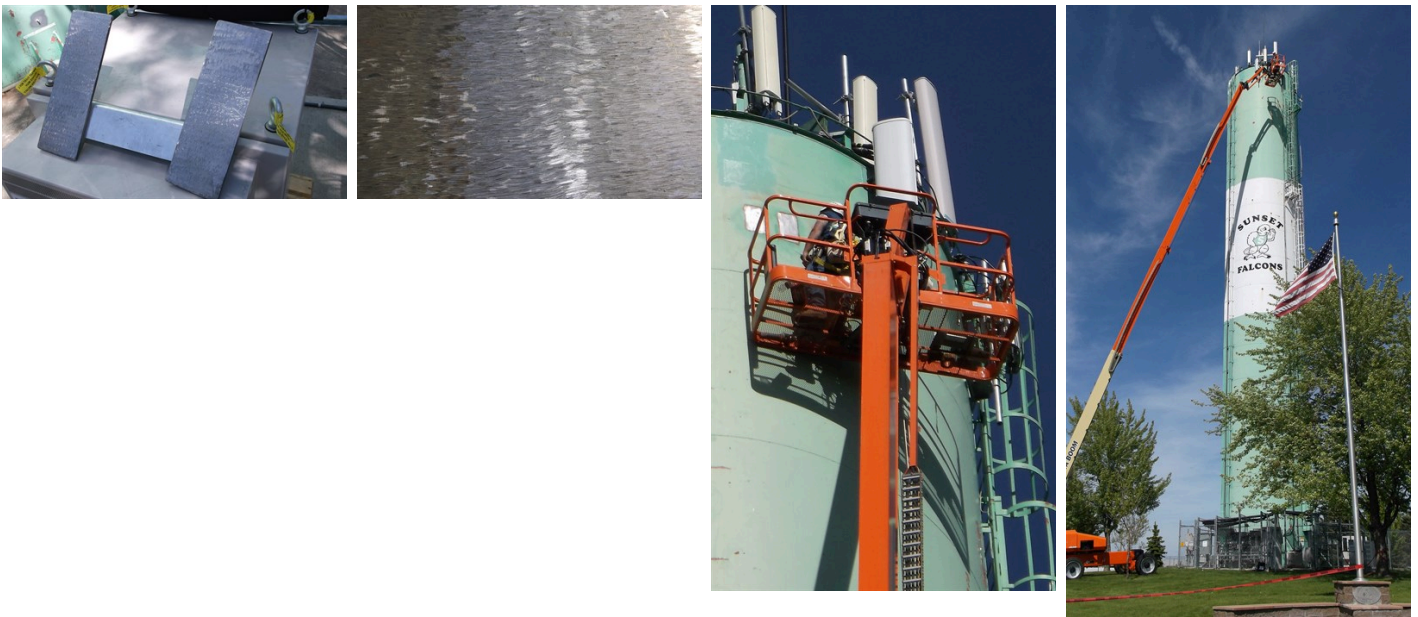
Photograph Descriptions

- * 1. Plates prepared ,
- * 2. Close-up of the prepared plates ,
- * 3. Ready to mount the plates ,
- * 4. Overview of cell phone antenna ,

Surface preparation on the plates was done with a grinder and the tank was done with MBX Bristle Blaster. After application, the

plates were held in place using 80lb. magnets placed underneath, and 'Gorilla' tape across the top until the Belzona 1111 had cured.
