STEEL OF A RAILWAY PROTECTED WITH BELZONA

ID: 5253

Industry: *Transport*
Application: *FPA-Floor Problem Areas*
Substrate: *Steel*
Products: ** Belzona 4151 (Magma-Quartz Resin) ,*

Customer Location: *Kitchener, ON, Canada*
Application Date: *March 2013*

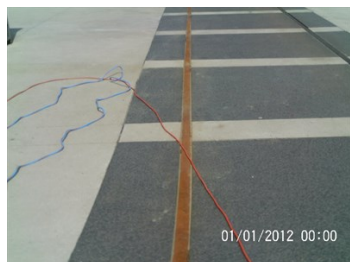
Corrosion on the steel of a railway.

- * Prior to application ,
- * Preparation in progress ,
- * Preparation in progress ,
- * Completed application ,
