# BELZONA REPAIRS AND RESURFACES FLOOR

ID: 5303

Customer Location: Toronto, ON, Canada  
Application Date: July 2013

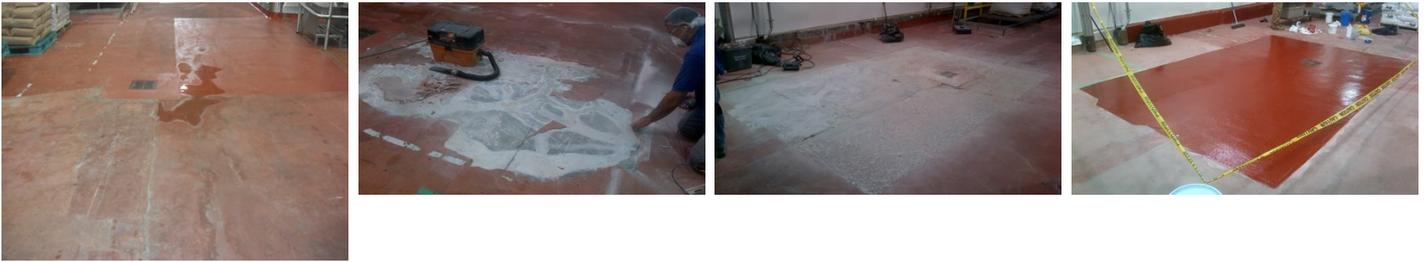
Over time, the floor had settled, resulting in standing water not flowing into the drain. This created an environmental hazard.

- \* Prior to application ,
- \* Preparation in progress ,
- \* Completed preparation ,
- \* Completed application ,

The application was carried out in accordance with Belzona Know-How System Leaflet FPA-1 for rebuilding worn and damaged floor surfaces. The surface was prepared by using a pneumatic hammer and ground to remove the existing concrete. Belzona 4911 was applied using a brush and Belzona 4131 was applied directly onto the conditioned surface, initially spreading to a general level using normal screeding techniques and then using a metal straight edge to achieve a uniform thickness.
