BELZONA REPAIRS AND PROTECTS HEAT EXCHANGER FROM CORROSION

ID: 5308

Application: HEX-Heat Exchangers

Tube sheets and end covers of a heat exchanger.

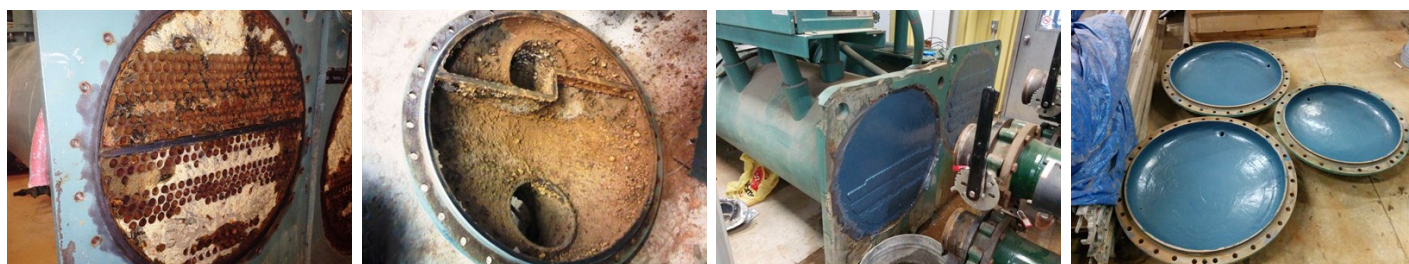
Photograph Descriptions

Pitting corrosion and bi-metallic corrosion caused leakage.

- * Prior to application ,
- * Prior to application ,
- * Application in progress ,
- * Completed application ,

The application was carried out in accordance with Belzona Know-How System Leaflet HEX-1 for repairing eroded-corroded tube sheets and HEX-3 for applying erosion-corrosion resistant coatings. The surface was abrasive blasted to prepare the area for application. Belzona 1111 was applied to the surfaces of the tube sheets and end covers to fill any pitting and damage using an applicator. Belzona 1321 was applied to the surfaces using a brush to protect against corrosion.
