# BELZONA PROTECTS TANK FROM CORROSION AND CHEMICAL ATTACK

Application: *TCC-Tanks and Chemical Containment Areas*

Slurry tank for water and solvents.

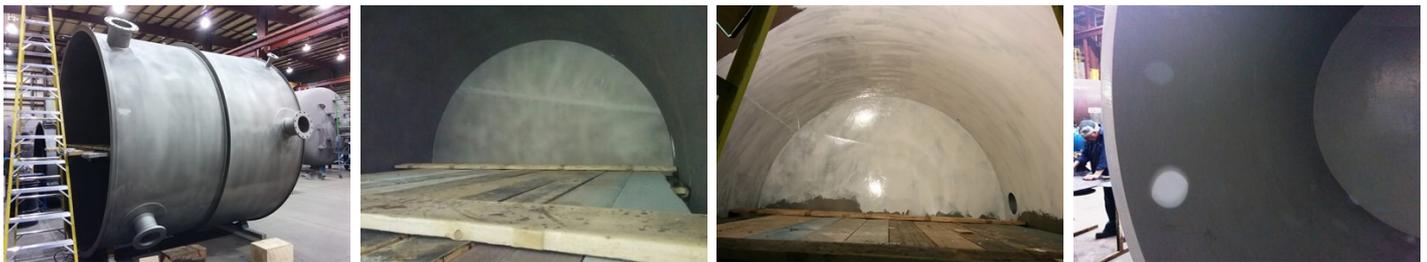
## Photograph Descriptions

*Protection of new build tank from corrosion and chemical attack.*

- \* New build tank ,
- \* Prior to application ,
- \* Application in progress ,
- \* Completed application ,

The application was carried out in accordance with Belzona Know-How System Leaflet TCC-3 for repairing/renewing damaged linings. Belzona 5892 was applied using a brush as a two coat system in accordance with Belzona Instructions For Use.
