BELZONA PROTECTS MAIN ON A MIXING TRUCK AGAINST ABRASION

ID: 5316

Application: SHM-Solids Handling Machinery

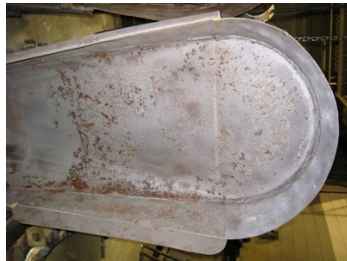
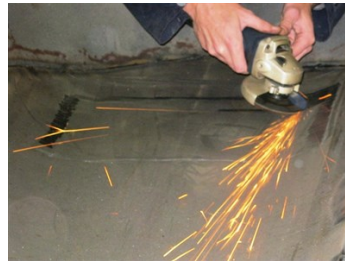
Photograph Descriptions

Impact and abrasion caused by flowing concrete.

- * Concrete mixing truck ,
- * Main prior to application ,
- * Preparation in process ,
- * Completed application ,

The application was carried out in accordance with Belzona Know-How System Leaflet SHM-13 for lining chutes and hoppers. The area was prepared using a hand grinder to create a cross hatch profile pattern. Belzona 1812 was applied directly onto the prepared surface with a plastic applicator in accordance with Belzona Instructions For Use.
