# BELZONA PROTECTS MAIN ON A MIXING TRUCK AGAINST ABRASION

ID: 5316

Application: SHM-Solids Handling Machinery

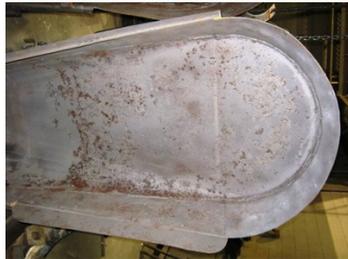
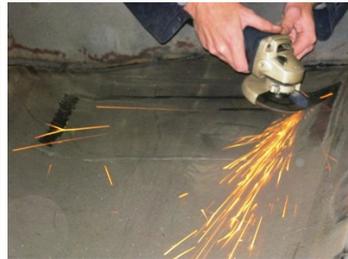
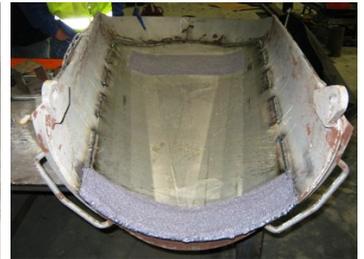
Impact and abrasion caused by flowing concrete.

- \* Concrete mixing truck ,
- \* Main prior to application ,
- \* Preparation in process ,
- \* Completed application ,

The application was carried out in accordance with Belzona Know-How System Leaflet SHM-13 for lining chutes and hoppers. The area was prepared using a hand grinder to create a cross hatch profile pattern. Belzona 1812 was applied directly onto the prepared surface with a plastic applicator in accordance with Belzona Instructions For Use.
