Protection of a chemical tank at very high temperature

ID: 5362

Industry: Chemical & Petrochemical
Application: TCC-Tanks and Chemical Containment Areas
Substrate: Steel
Products: * Belzona 1591 (Ceramic XHT Metal),

Customer Location: Lavéra, France
Application Date: May 2012

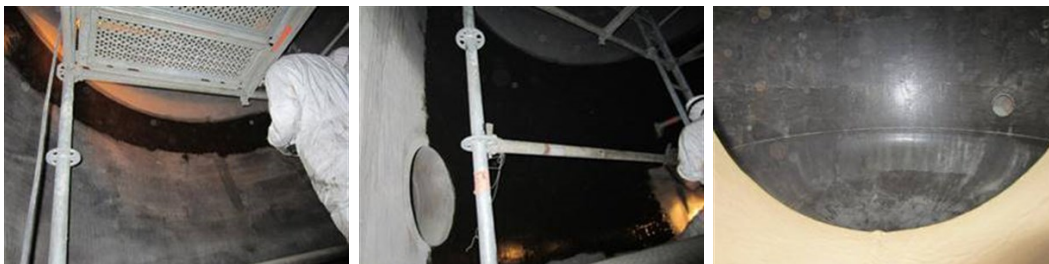
Photograph Descriptions

Tank made of steel can be easily attacked by chemicals at high temperature (165°C)

- * Blasted surface, ,
- * On-going application, ,
- * Finished application ,

Tank F110 (diameter : 3m, height : 3,1m)

Application realised in accordance to Belzona system leaflet TCC-5. After degreasing and blasting, Belzona 1591 was applied in a one-coat system (between 600 and 800µm).
