# Belzona keeps the rain off the shop floor

ID: 5377

Application: FPA-Floor Problem Areas

Pump shop forklift traffic area

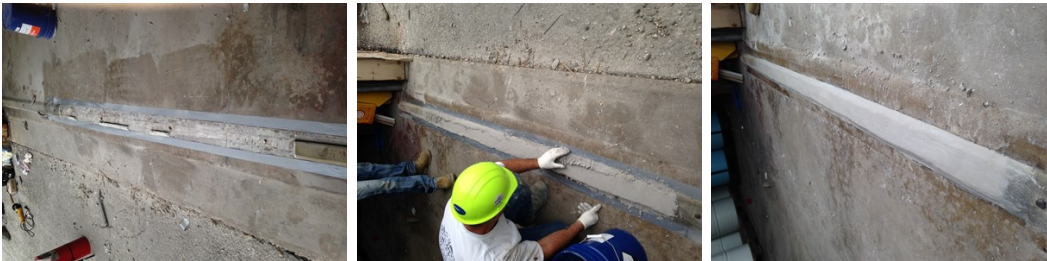
## Photograph Descriptions

*With heavy rains the customer's shop floor would flood causing slip hazards, a previous effort of building a curb had failed quickly from the forklift traffic.*

- \* Application area being prepared ,
- \* Belzona 4111 being applied to wet out the surface ,
- \* Completed curb using Belzona 4111 ,

Application was carried out using a modified version of Belzona Know-How System Leaflet FPA-1. After proper surface preparation a thin layer of Belzona 4911 conditioner was applied for proper bonding. Belzona 4111 was then used to form the curb.

Previous repair lasted only weeks, after 6 months in service the customer noted the Belzona application looked as good as the day it was installed and he no longer had to limit the loads going into the shop. The shop floor now stays dry during heavy rain. Belzona 4111 was selected to build the curb because of it's high load and erosion resistance properties.
