# BELZONA IMPROVES EFFICIENCY OF JET DUCTS

ID: 5386

Industry: *Marine*  
Application: *SOS-Ships and Offshore Structures*

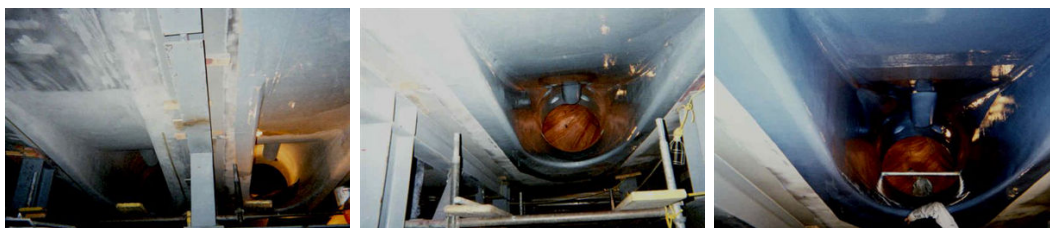
- \* View of ducts after grit blasting. ,
- \* Application of 1st coat of Belzona 1341 (Grey) in progress. ,
- \* Completed application of 2nd coat of Belzona 1341 (Blue). ,

The application was carried out in accordance with Belzona Know-How System Leaflet SOS-2.

Belzona improved the efficiency of the jet ducts. Because of the very slick nature of the coating, it has the ability to improve flow and reduce turbulence in fluid flow situations.
