BELZONA REPAIRS AND PROTECTS HOUSING

ID: 5395

Industry: *Marine*
Application: *SOS-Ships and Offshore Structures*

Substrate: *Cast Aluminum*
Products: ** Belzona Marine Metal ,*
** Belzona 1321 (Ceramic S-Metal) ,*
** Belzona 9411 (Release Agent) ,*

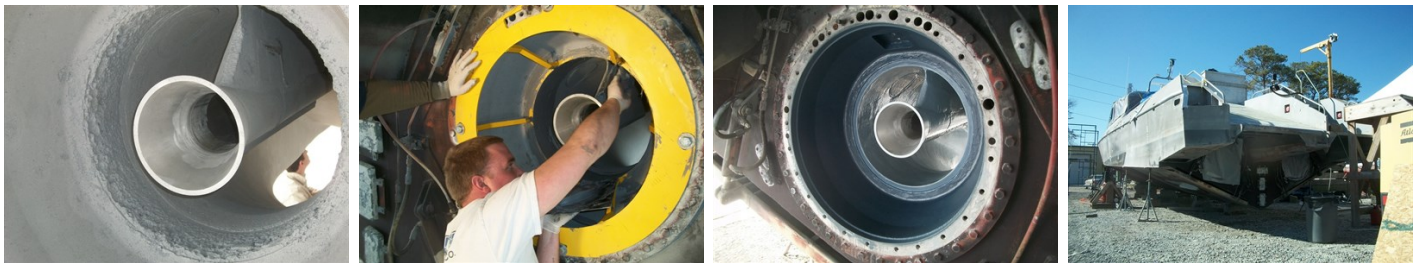
Severe erosion and pitting of the jet drive transom housings threaten the service life cycle of the equipment and reduce the efficiency of the jet drive system.

- * Blasted port transom housing ,
- * Mold is in place and the Belzona rebuilding metal is being applied to return the housing to the original dimensions and contours ,
- * The completed port transom coated with Belzona 1321. The molded jet drive clearances are perfect ,
- * Stern view of the Special Operations Craft and the transoms (covered by tarps) ,

Erosion and corrosion caused a major loss of metal in the jet drive transom housing.

The transom housing was blasted to a near white metal finish. A former was manufactured to mold the critical clearances to 1-2 mm between the removable jet drive and the boat transom housing. Once the rebuilding and molding was completed, two coats of Belzona 1321 were applied.
