# BELZONA PROTECTS AGAINST HOT SULPHURIC ACID

ID: 5475

Industry: Chemical & Petrochemical  
Application: TCC-Tanks and Chemical Containment Areas

Customer Location: Chemical Company, Warrington, UK  
Application Date: September 2014

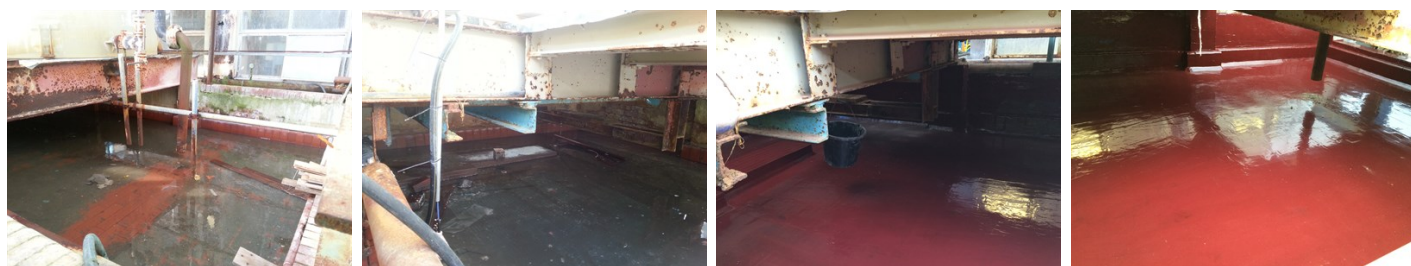
## Photograph Descriptions

The tiles were on the base of the bund and a couple of inches up the walls. As the standing water levels were above the tiles, it was leaking through the bricks. The tank inside was storing 77% sulphuric acid at 70°C. It was therefore decided to coat the bund.

- \* Damaged bund area ,
- \* Damaged bund area ,
- \* & 4. Completed application ,

The application was carried out in accordance with Belzona Know-How System Leaflet TCC-15. Belzona 4131 was used to create fillets at the horizontal and vertical junctions before Belzona 4341 was applied to protect the entire area.

The entire application was completed in 5 days. Despite the harsh conditions Belzona 4341 can resist high concentrations of sulphuric acid up to 90°C. As Belzona products are non-porous, this eradicates the problems that could be incurred through acid leakage.
