BELZONA PROTECTS PIPE WITH INTERNAL LINING

ID: 5524

Industry: Oil & Gas
Application: VPF-Valves, Pipes and Fittings
Substrate: Carbon Steel
Products: * Belzona 1121 (Super XL-Metal) ,
* Belzona 5891 (HT Immersion Grade) ,

Customer Location: Oil and Gas Company, BA, Brazil
Application Date: July 2009

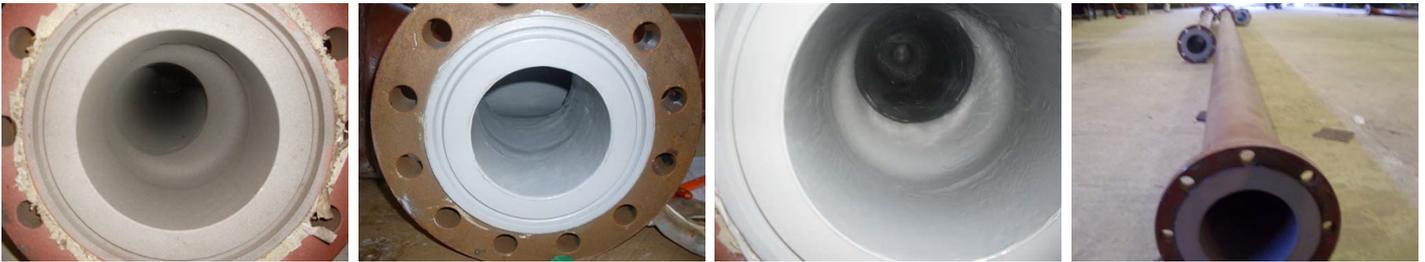
Photograph Descriptions

- * Internal surface after blasting. ,
- * Internal surface of the pipe coated with Belzona 5891. ,
- * Close-up after the application of Belzona 5891. ,
- * Overview of the pipelines. ,

The weld seams and irregularities were roughened by grinding. The internal surface of the pipes was prepared by blast cleaning to a near white metal finish, SSPC SP-10 Sa 2½ standard. After the removal of residue and cleaning with a degreaser, Belzona 1121 was applied to smooth the weld seams/irregularities. Then the 1st layer of Belzona 5891 was applied at a thickness of 300-400 microns. After the initial mechanical stability of Belzona 5891, brush-off blast cleaning was carried out and the 2nd layer of Belzona 5891 was applied at a thickness of 300-400 microns. In the straight sections, the coating of Belzona 5891 was applied. Inspection was carried out and the identified misses were retouched.
