# BELZONA BONDS RISER BEARINGS ON OFFSHORE PLATFORM

ID: 5539

Risers and Riser housings needed protection on a new build Central Processing Facility.

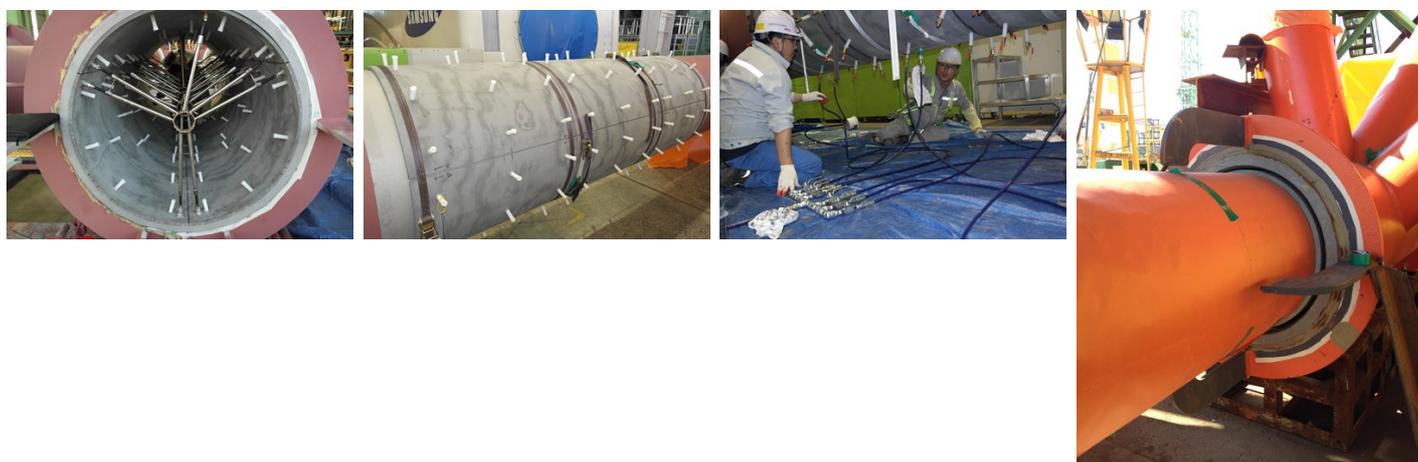
When stationed, Risers move inside the housings, creating abrasion and exacerbating corrosion. The decision was made to protect these areas with composite bearings. As the Bearings reached 2.5m diameter and 3m length they were split into (up to 16) sections and had to be bonded in place. A total of 84 risers and housings were completed on the hullside and 27 on the topside.

- \* Fitting Bearing to Housing ,
- \* Fitting Bearing to Riser ,
- \* Injecting Belzona 1321 ,
- \* Riser inserted into Housing ,

The application was carried out in accordance with Belzona Know-How System Leaflet GSS-9. The Bearings were aligned in place using jigs, straps and injection port bolts. The Bearing had to be jacked to 4mm from the substrate. The seams were then dammed

using Belzona 1111. Belzona 1321 was injected through the injection ports. After curing the injection ports were cut off, filled with Belzona 1111, and ground flush.
