# Belzona Protects Fans From Abrasion

Industry: General Industry  
Application: FBC-Fans, Blowers and Compressors

Customer Location: Tobacco company, Egypt  
Application Date: February 2002

Substrate: Steel  
Products: \* Belzona® 1812 (Ceramic Carbide FP) ,

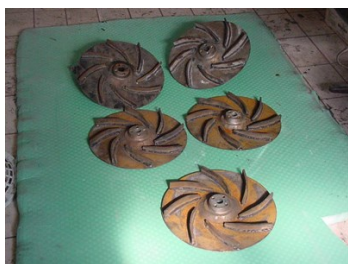
- \* General view of tobacco suction fans ,
- \* Fans following surface preparation ,
- \* Fans coated with Belzona® 1812 (Ceramic Carbide FP) ,
- \* Five fans were protected ,

The tobacco suction fans were worn out and replaced every three months. After coating the fans with Belzona® 1812 the fans provided over a year of service before they are touched up. Other fans in the tobacco facility are coated regularly.
