BELZONA PROTECTS NEW BUILD DESALTER

ID: 5540

Customer Location: Refinery, UK
 Application Date: January 2014

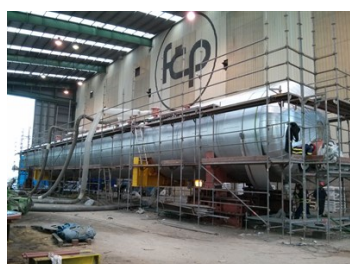
Desalter

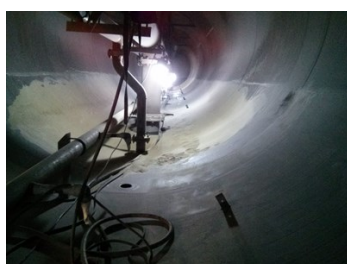
Substrate fully grit blasted.

Application was carried out in accordance with Belzona Know-How System Leaflet TCC-5. Belzona 1591 applied to the bottom third of the vessel.

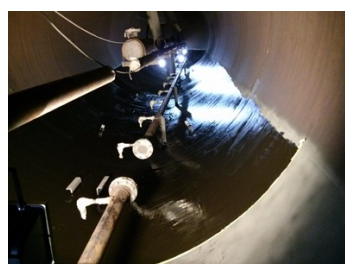
Finished application.

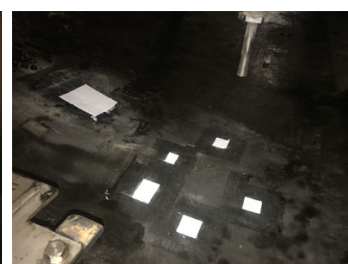
Remedials in November 2020 with Belzona 1593.

The sheer size of the vessel (35.6 m (117 ft) long x 3.6 m (11'9") ID) required a dedicated team from Belzona to train and validate the application contractor, provide field support with a coating inspector and a bilingual project supervisor. The lining project was successfully completed in March 2014 to the required specification and schedule agreed with the client. In the future such projects will be completed with Belzona 1593, which offers significant benefits in application ease. In November 2020, the vessel was inspected by engineers and the coating was found to be in excellent condition apart from some small defects to the top coat. A small number of remedial repairs were undertaken which amounted to 4 units of Belzona 1593 and the vessel was put back into service until the next inspection interval in 6 years.
