# BELZONA PROTECTS NEW BUILD DESALTER

ID: 5540

Application: TCC-Tanks and Chemical Containment Areas

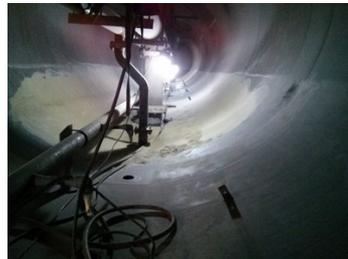
Desalter

Substrate fully grit blasted.

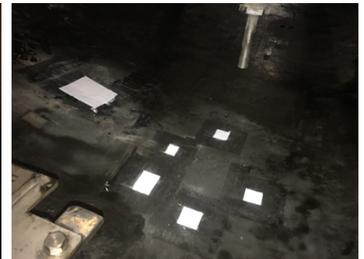
Finished application.

Remedials in November 2020 with Belzona 1593.
