BELZONA IMPROVES SAFETY AT SHOPPING CENTER

Application: FPA-Floor Problem Areas

Customer Location: Council Owned Shopping Center, UK

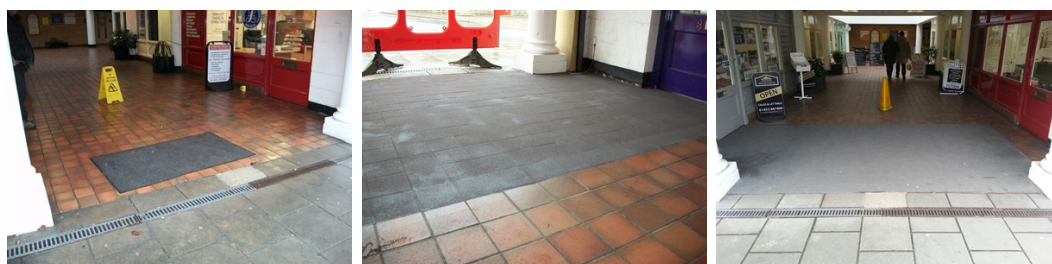
- * Hazardous area at the entrance to the shopping center ,
- * Slip reduction system introduced in 2011 ,
- * System still in place in 2015 ,

The main entrance to the shopping center had become a slip hazard. The council had previously tried to put a mat down to reduce the hazard, however, this only lead to more accidents.

The application was carried out in accordance with Belzona Know-How System Leaflet FPA-8. After repairing broken tiles with Belzona 4111, Belzona 5811 was applied thinly as a two coat system before Belzona 9231 was sprinkled onto the surface to give the desired level of grip.

The application was completed in 2 stages to allow the shopping center to continue to trade with minimum disruption. It was also carried out through the cold winter period. The system was revisited in February 2015 and it is still exhibiting excellent slip

resistance. Thousands of people have been walking over it and the council has not had one slip, trip or fall reported in four years!
