# BELZONA CORROSION PROTECTION FOR SUCTION SCRUBBER

Industry: Oil & Gas  
 Application: TCC-Tanks and Chemical Containment Areas  
 Substrate: Carbon Steel  
 Products: \* Belzona 1522\* ,  
 \* Belzona 1391 (Ceramic HT) ,  
 \* \*Belzona 1523 is the new version ,

Customer Location: Oil and Gas Industry, North Sea, UK  
 Application Date: 2003

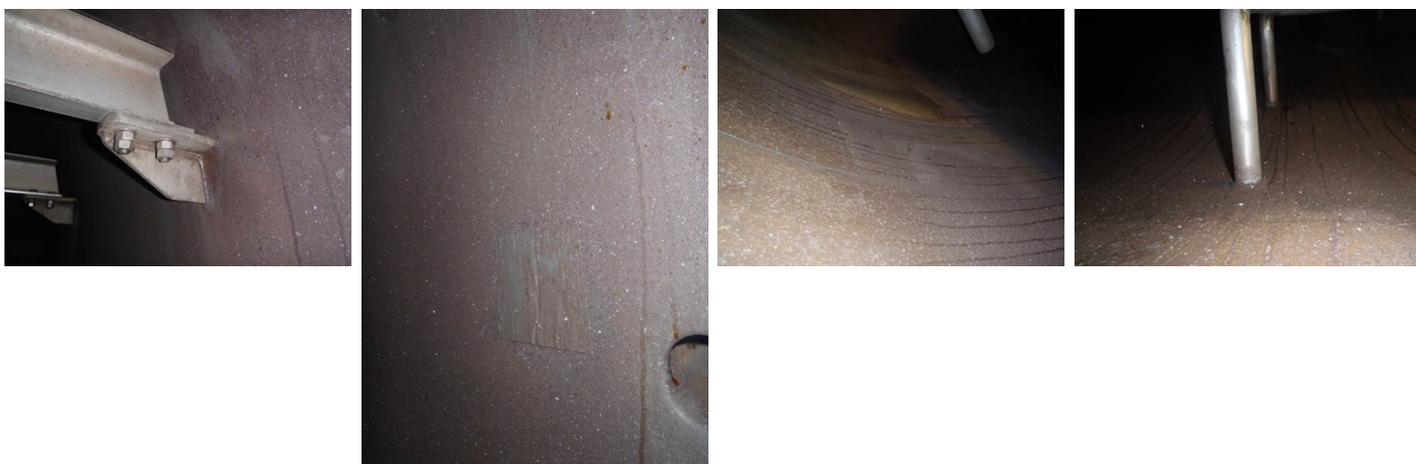
- \* Inspection in 2013 - Inside view of the scrubber ,
- \* Patch repair ,
- \* Different view of patch repair ,
- \* View around ladder ,

The application was carried out in accordance with Belzona Know-How System Leaflets TCC-3 and TCC-5. Belzona 1522 applied by Plural spray and Belzona 1391 applied by hand to nozzles etc.

Belzona lining was specified to protect new process vessels and utility tanks. Based on Belzona track record since the 1990s, the customer opted for a carbon steel shell lined with Belzona rather than stainless steel cladding. During the 2013 inspection, it was reported that the Belzona lining was in excellent condition. Local repairs carried out during the initial application were still in very good condition with no sign of degradation.
